### Failed MGB bonnet catch – an alternative solution

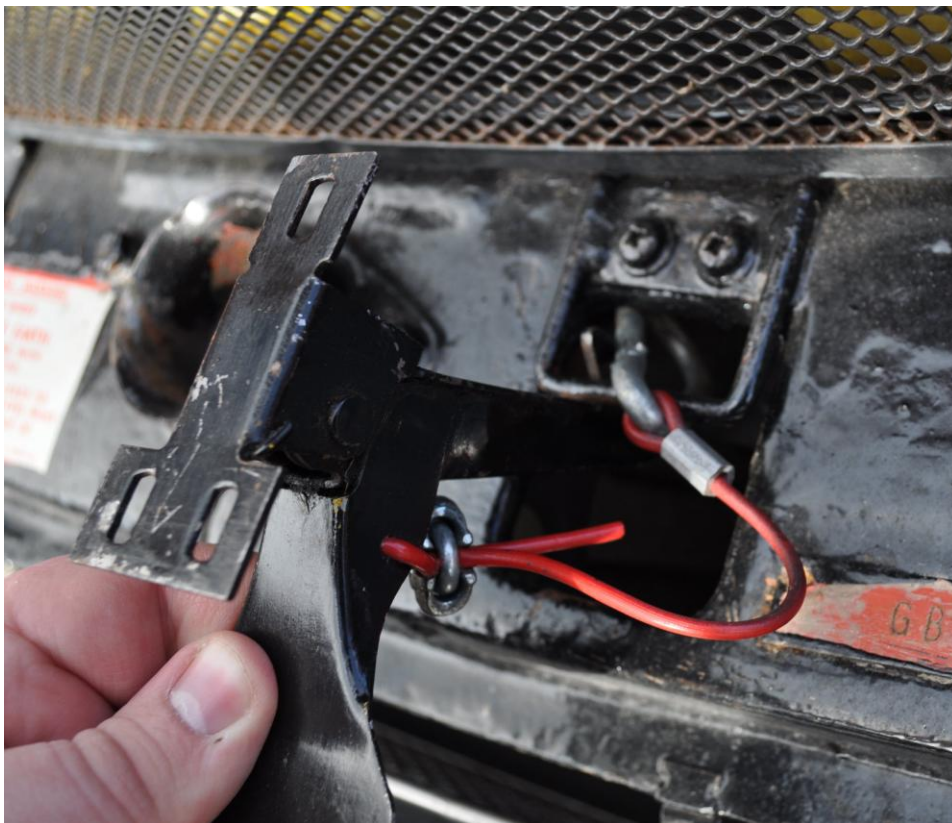
bracket on the slam panel of the car. The other end of the suitably shortened cable is secured to the original safety catch with a clamp.

- Remove the 3 bolts holding the safety catch to the bonnet.
- Drill two small holes through the handle of the release mechanism.
- Shorten the cable to around 8 inches in length.
- Pass the cable through both of your pre-drilled holes and loosely fit the clamp.
- Reattach the safety catch to the car.
- Adjust the length of the cable to suit the car. You should aim to keep the cable as short as possible whilst giving enough free play so you have space to reach in and operate the sprung arm of the carabiner.
- Tighten the clamp up and trim off the excess cord.

The plus points of this modification are it allows the car to maintain a standard outward appearance but gives a third layer of security in case the bonnet catch and original safety catch fail. The only down side is that you will need to release the sprung clip of the carabiner every time you open the bonnet, but arguably this is no more effort than having a leather type bonnet strap fitted?

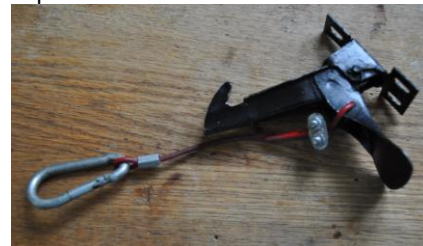
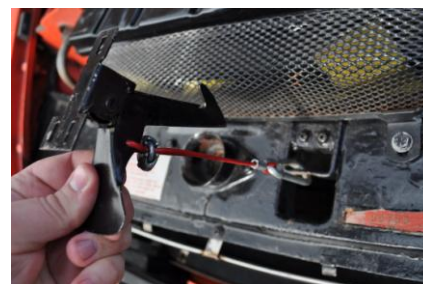
The solution I came up with was to utilise a "break away cable" kit as you can find fitted to caravans or boat trailers and a small U clamp. The kit adapted to the MGB bonnet comprises of a simple sprung clip, like a carabiner, at one end which should be attached to the existing U
